Studies on the role of improvement perimeters in preventing and combating soil erosion

Abstract. Work conducted over the course of a year have had as primary purpose the effect of ecological reconstruction through afforestation and other works (support fences, cross and longitudinal works în ravinees) in improvement perimeters Diviciori 1 (compartment 73) and Diviciori 3 (compartment 49). Forest vegetation was installed 30 years ago in 73, according to afforestation formula 7PiN-2Pa (Fr) -1 seabuckthorn and 50 years in 49, according to the afforestation formula: 5PiN-2Pi-3Mo. Stands were led using silvotechnic works were just regarding hygienization, in the first years. However, in the recent past, the trees have suffered due to abiotic factors that favored the emergence of disease and pests (*Lophodermium* ssp. and *Diprion pini*). So as to obtain more relevant scientific data, test surfaces were placed following the methods used in the agricultural field, modified as to fit the forest field, so the data could be statistically processed and allow the recommendation of adequate technical solutions regarding the ecological reconstruction of the damaged terrains. Eight test areas we

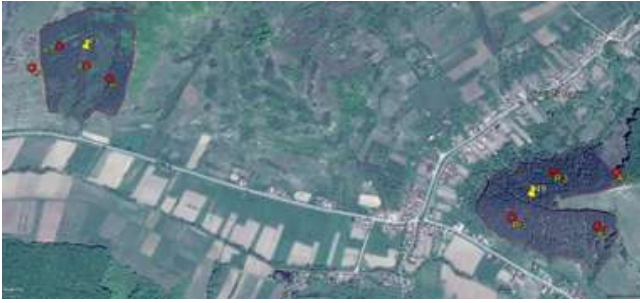
Figure 1. Location of runoff plots.

The works, studies, analysis were carried out in the improvement perimeters of Diviciori 1 (compartment 73) and Diviciori 3 (compartment 49), managed by Forest District Gherla, forests located in the area of Diviciorii Mari, Cluj county. The forest vegetation was installed 30 years ago in the compartment 73 and 50 years ago in the compartment 49 on degraded lands, with the aim of stopping the erosion phenomena (Figure 1).

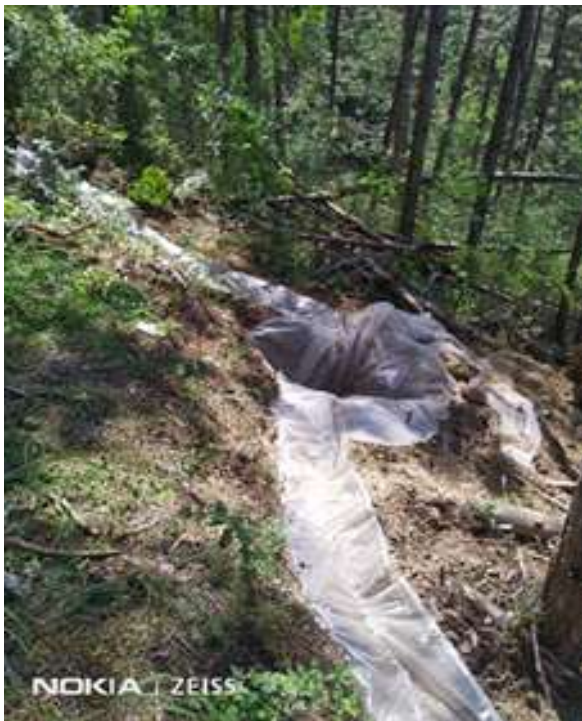
Figure 2. Water catchment system in the forest.

The dimensions of the runoff plots were established at 200 square meters, the side where the water collection systems were located 10 meters, and the basin having the dimensions of 1 meter length and width, and depth of 0.5 meters, the equivalent to 0.5 cubic meters, lined with foil, for water retention (Figures 2 and 3).

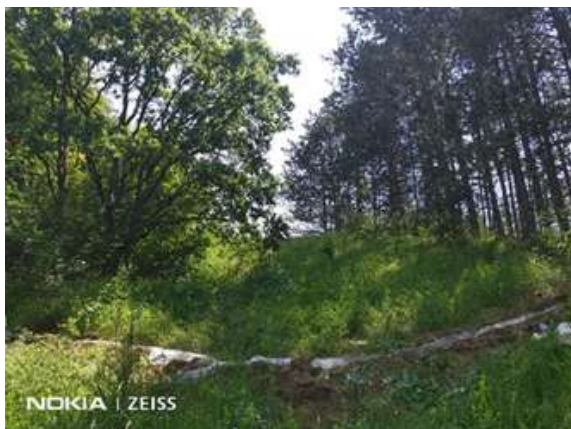
Figure 3. Water catchment system outside of the forest.

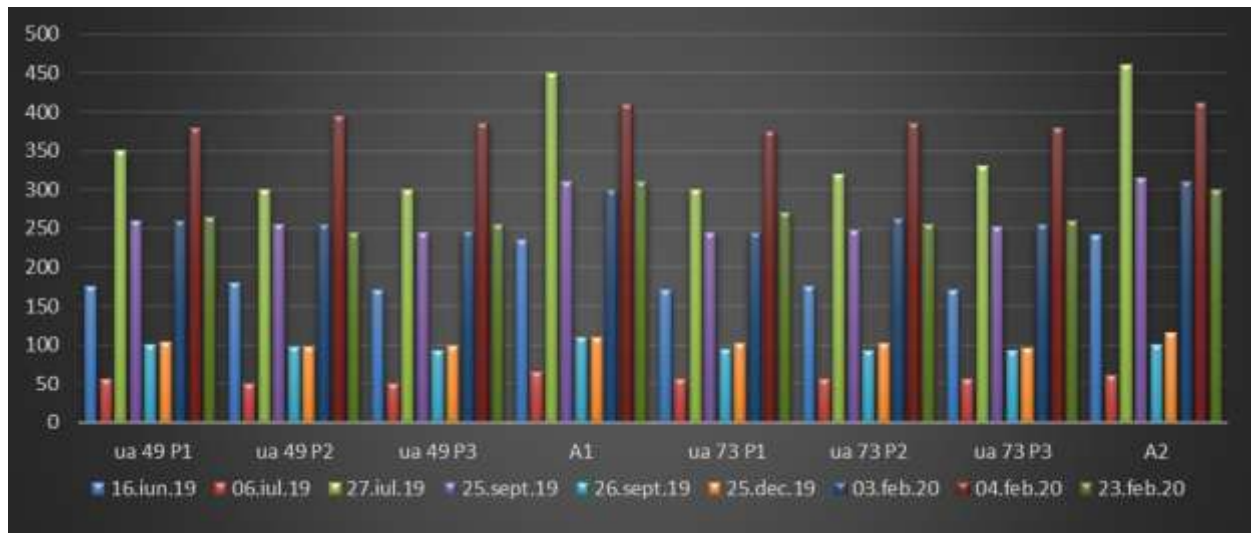
Figure 4. Surface leakage from experimental surfaces, correlated with rainfall intensity (L/basin).

The leaks measured in the field and presented in Figure 4 show a certain uniformity inside the forest,

respectively a slight differentiation outside the forest, although they came from precipitation with low and medium intensities (on July 27, 2019, February 4, 2020 and February 23, 2020). The largest leaks were recorded in plot A2 outside the forest, near compartment 73, being located in completely uncovered land, with a southern exposure, where insolation and evapotranspiration is much stronger, affecting the installation of vegetation.

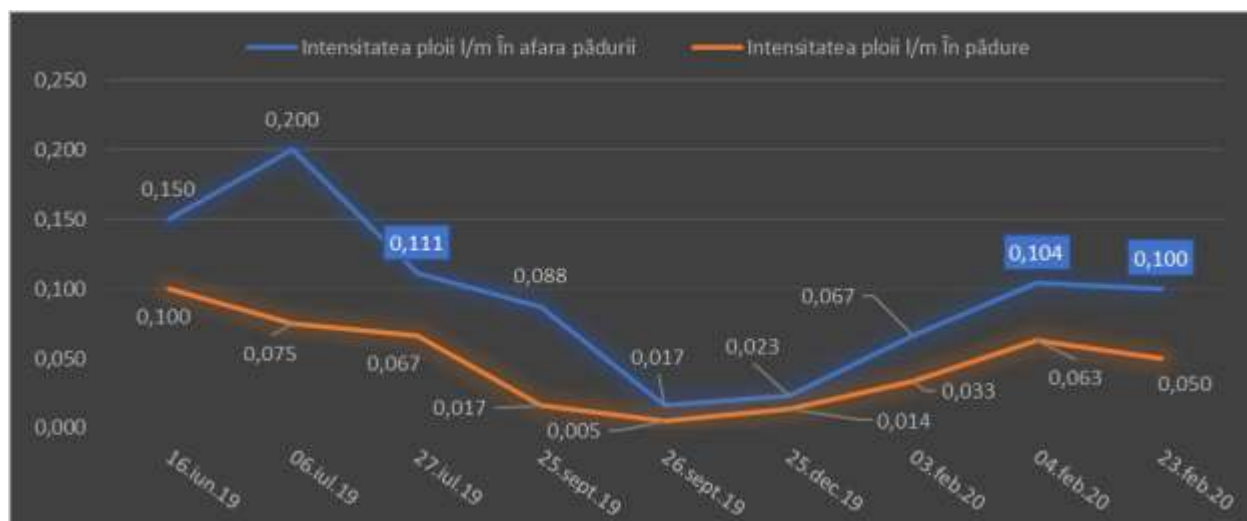
Figure 5. Rainfall intensity of the analyzed period (L/m²).

Flows were analyzed comparatively after each rain, between June 16, 2019 and February 23, 2020. Their amount is directly influenced by rain intensity (Figure 5), slope, soil texture and moisture, and obstacles encountered within the test surface, such as would be trees, subshrub, seedling, herbaceous blanket, litter, etc.

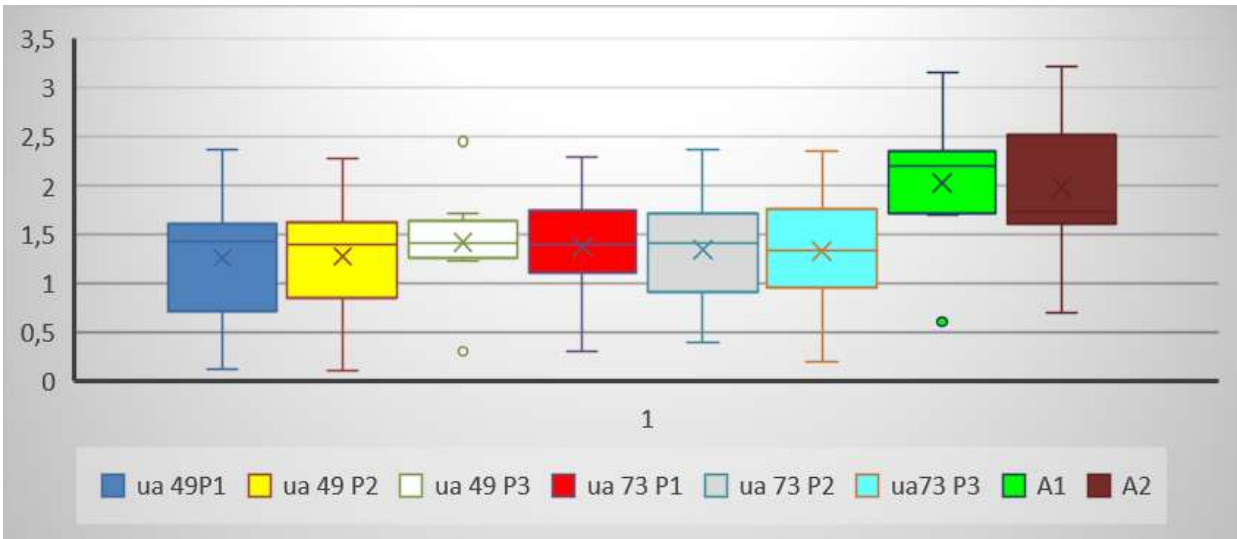
Figure 6. Eroded material from the samples taken (g/0.5 L).

Regarding the deviations from the average in the runoff plots, we find that in the case of 49, plot 1 (Figures 6 and 7) are the largest, the cause being the steep slope, the litter, the herbaceous blanket, and shrubs having an uneven distribution in the contents of the plot.

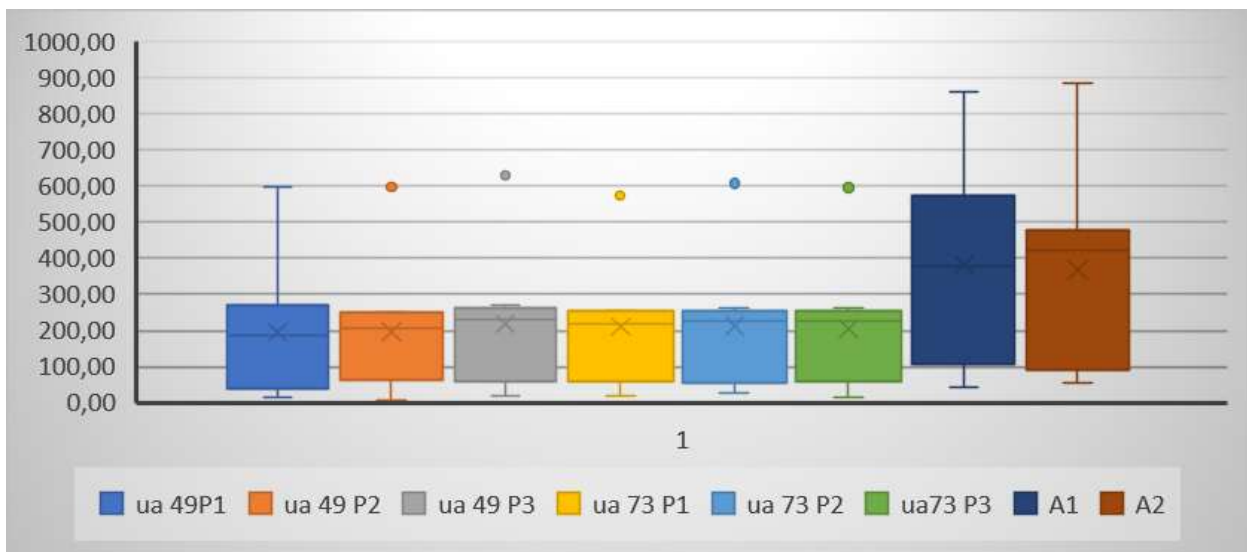
Figure 7. Eroded material on the experimental surface (grams).

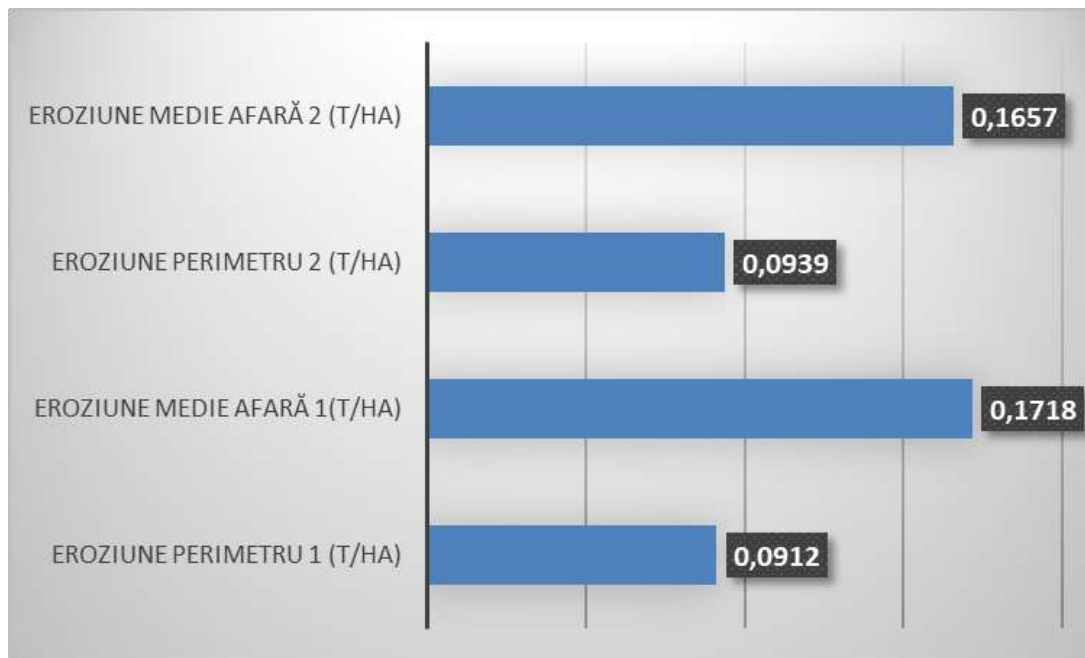
Figure 8. Determination of erosion in plots 49 and 73 and limitrophe.

Based on the results obtained on each basin, the erosion per hectare was calculated for each perimeter taken in the study and comparatively the erosion outside the forest was determined, during the period during which the study was carried out (Figure 8).

We notice that the erosion differences in the forest are by 0.0806 t/ha (46.92%) smaller in case of compartment 49, compared to A1, and in compartment 73 they are by 0.0718 t/ha (43.33%) smaller than in A2.
